# USAAVLABS TECHNICAL REPORT 66-27

## AIRCRAFT LITTER RETENTION SYSTEM DESIGN CRITERIA

U. S. ARMY AVIATION MATERIEL LABORATORIES  
FORT EUSTIS, VIRGINIA

CONTRACT DA 44-177-AMC-254(T)  
AVIATION SAFETY ENGINEERING AND RESEARCH  
A DIVISION OF  
FLIGHT SAFETY FOUNDATION, INC.  
PHOENIX, ARIZONA

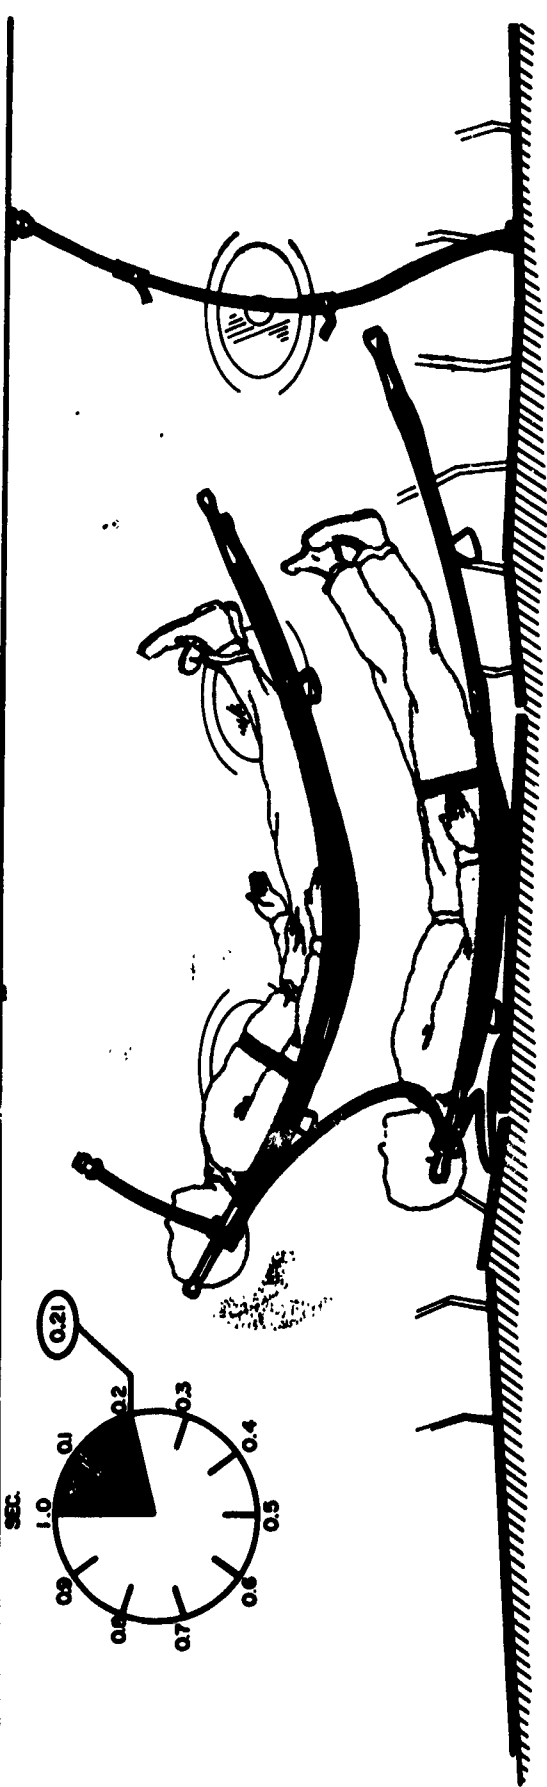
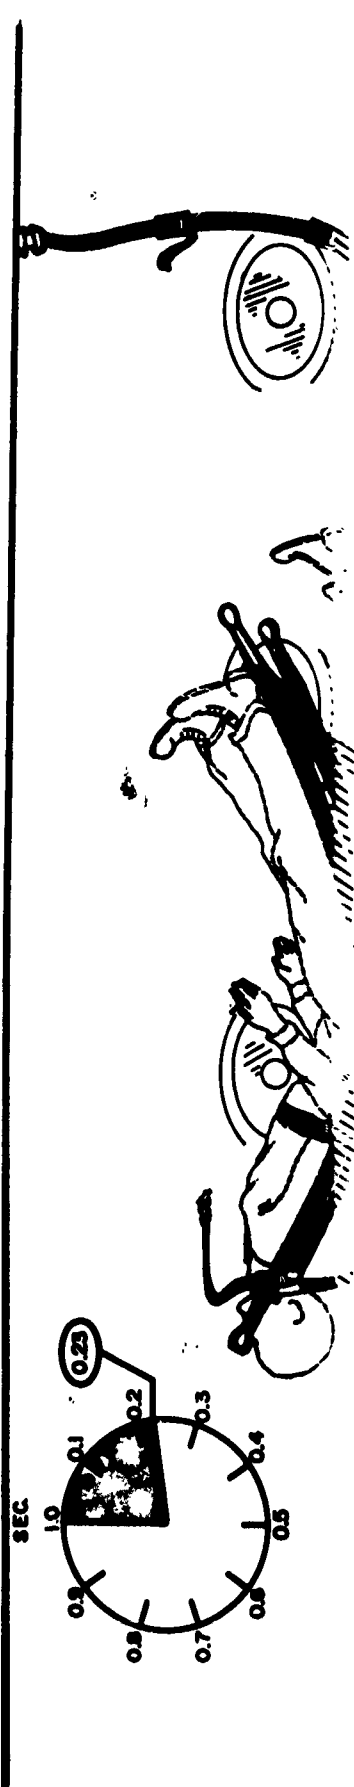
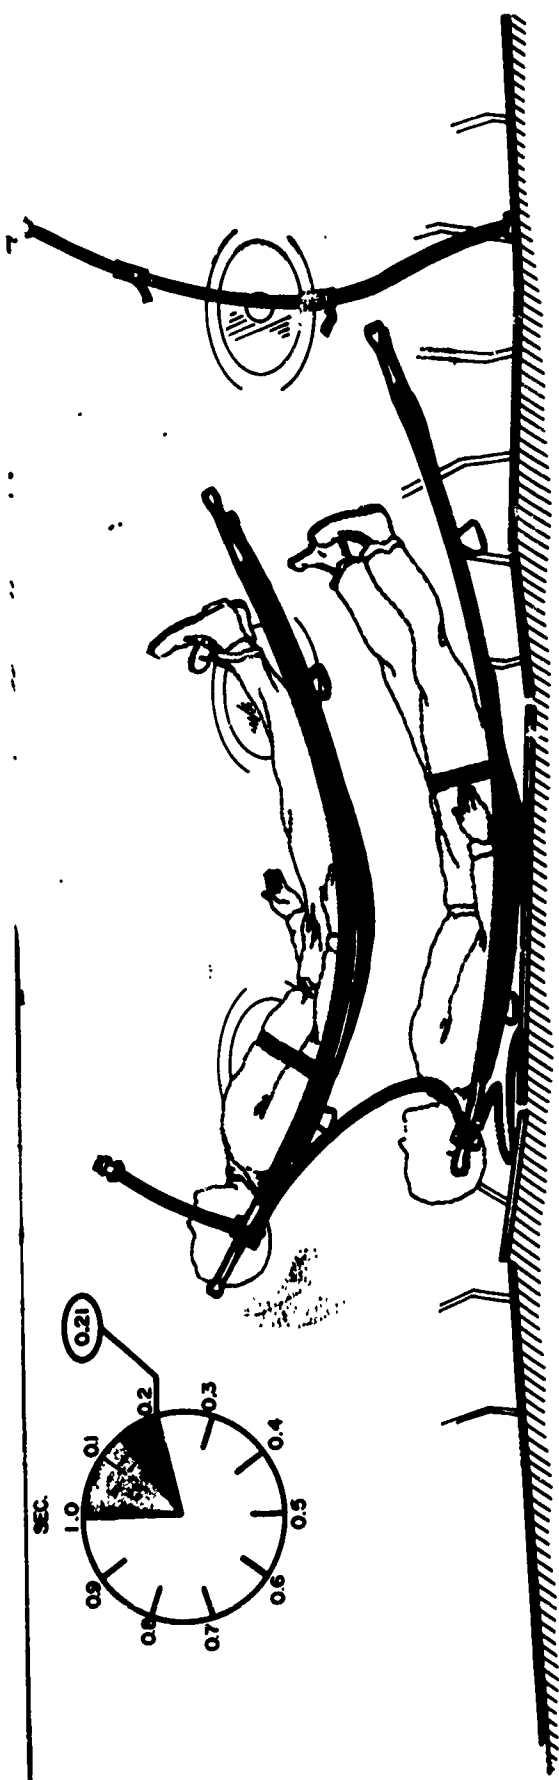
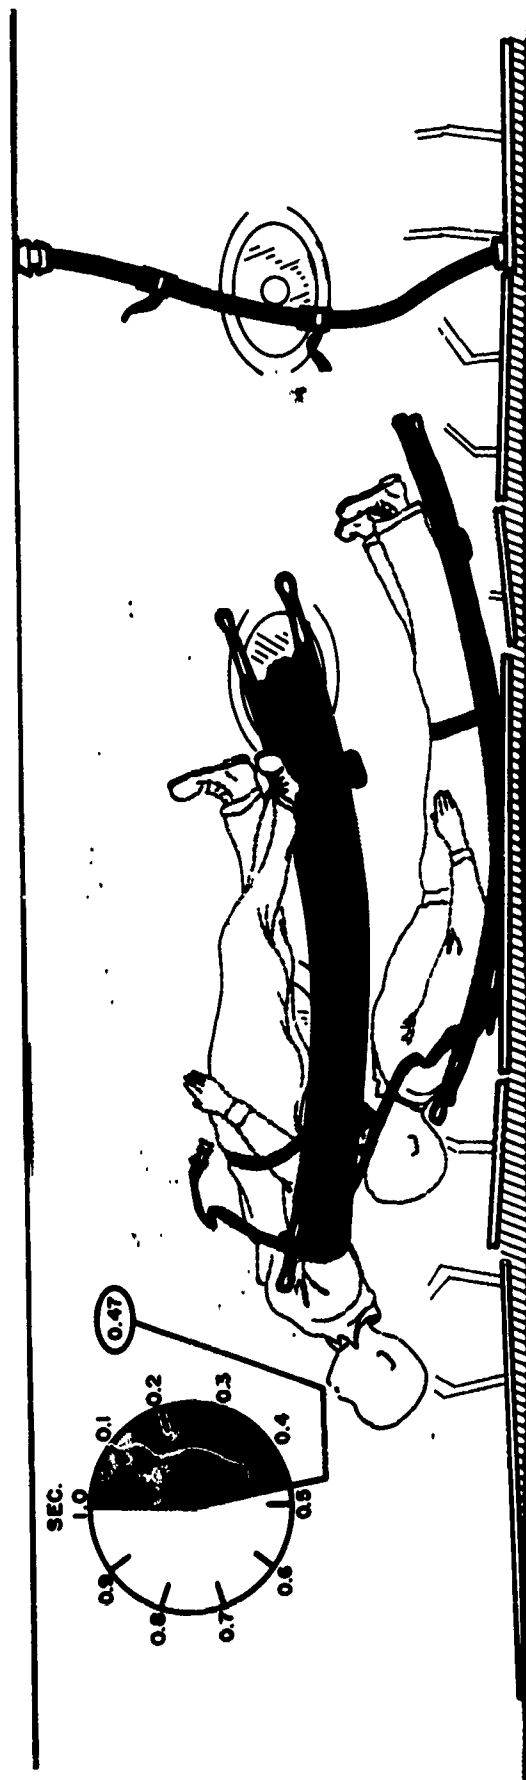
Figure 3. Kinematics of CH-21 Litter System Failure.

The results of an actual crash test of the litter system in Figure 1 are shown in the kinematic drawing, Figure 3. A description of the conditions that existed in the full-scale dynamic crash test (which included this litter system) is given in Reference 2. The results of the test of a standard UH-1D litter system installed in a modified CH-21 are described in Appendix I.

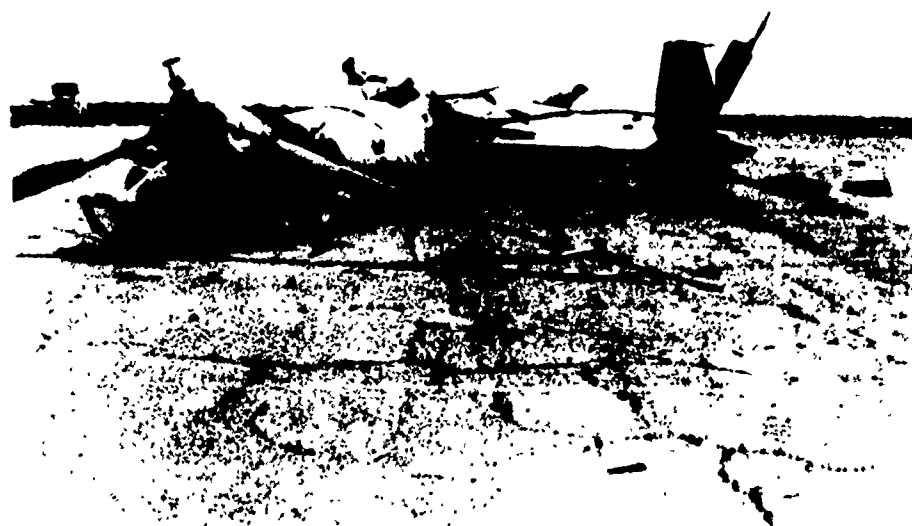
The test vehicle was crashed onto an asphalt runway from a maximum height of 111 feet above the ground. At impact, vertical velocity of the helicopter was 52.5 feet per second and horizontal velocity was 66.0 feet per second. These conditions resulted in a velocity of 89.3 feet per second along a 38-degree flight path. This combination of conditions produced a severe crash as shown in Figure 15, resulting in structural damage which varied in severity along the inhabitable length of the fuselage as shown in Figure 16.

Figure 15. Postcrash Condition of Test Helicopter.

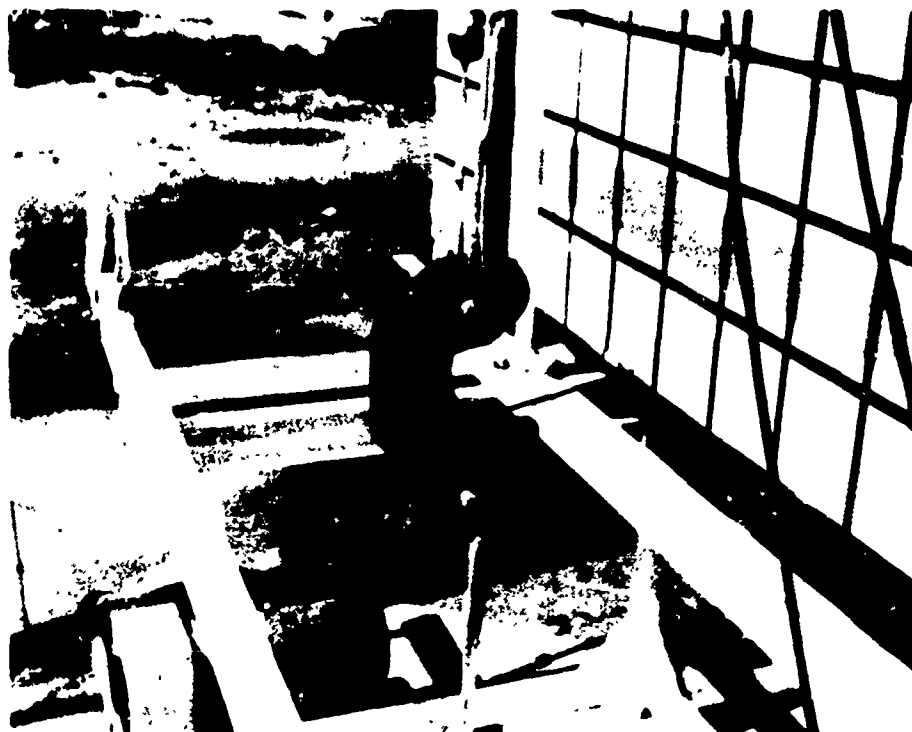
Figure 32. Litter Bracket With Positive Lock.

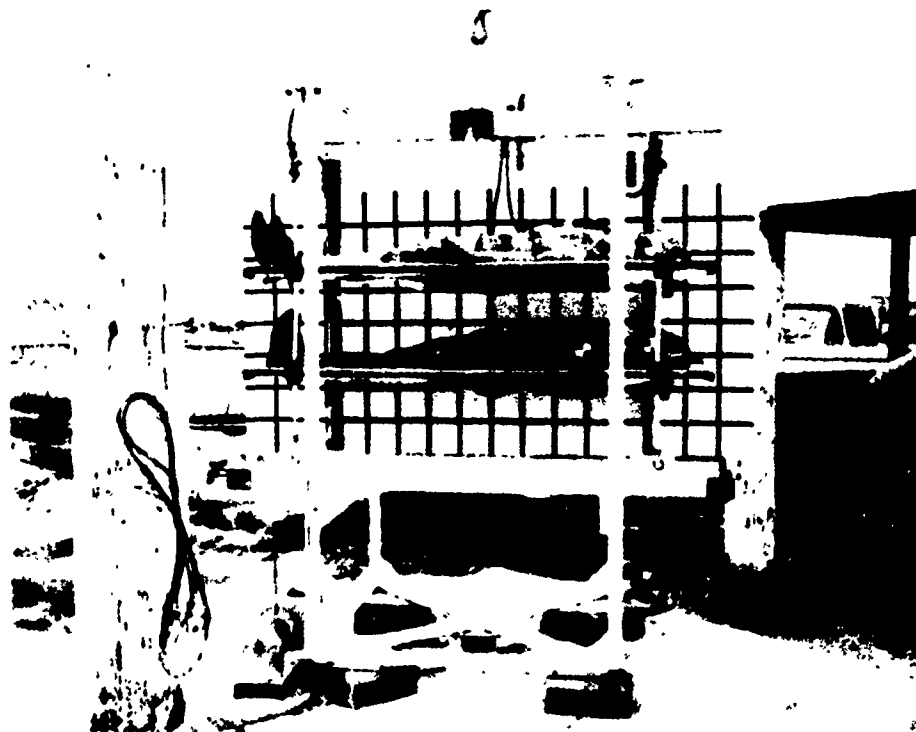
Seven dynamic tests were performed on the system using the drop tower. After the first few drops, it was discovered that the positive lock to the litter pole still caused eccentric loading of the bracket when dynamic loading caused the litter pole to bend. This problem was overcome by the design and installation of a stronger bracket. Subsequent drops verified the adequacy of the stronger bracket when subjected to eccentric loading.

Figure 33. Drop-Tower Testing Device.

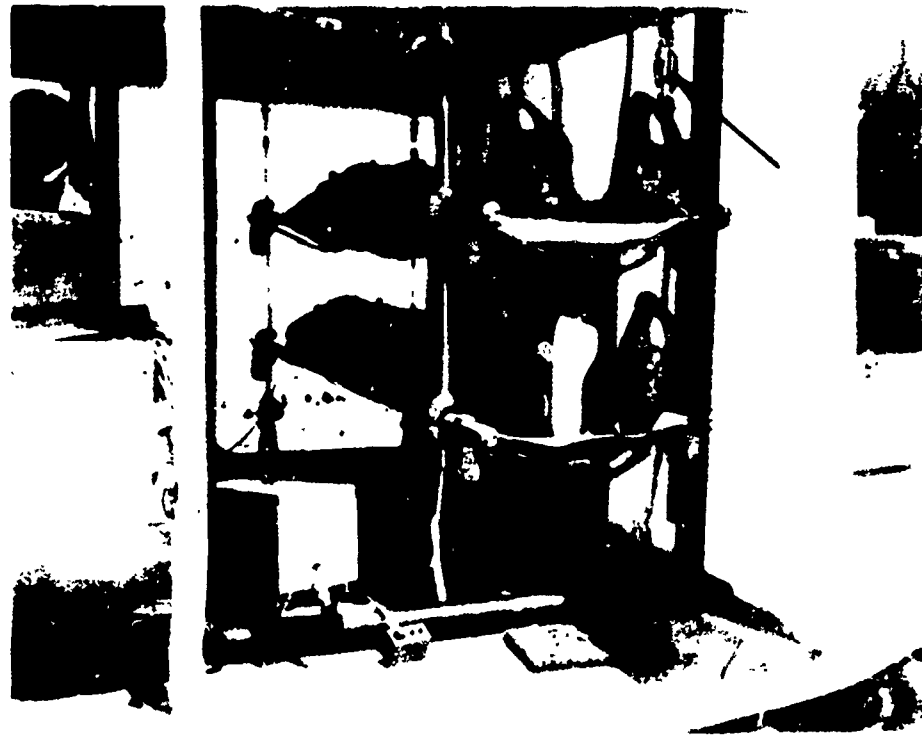
In the second phase of the testing program, the experimental litter system was installed in a modified XH-40 (prototype UH-1) helicopter and subjected to a dynamic crash environment. Load limiters designed to limit vertical acceleration on the occupied litter to 20G were installed. Figure 34 shows the experimental litter system installation in the XH-40 (note arrow pointing to load limiters).

Figure 34. Experimental Litter Installation in XH-40.

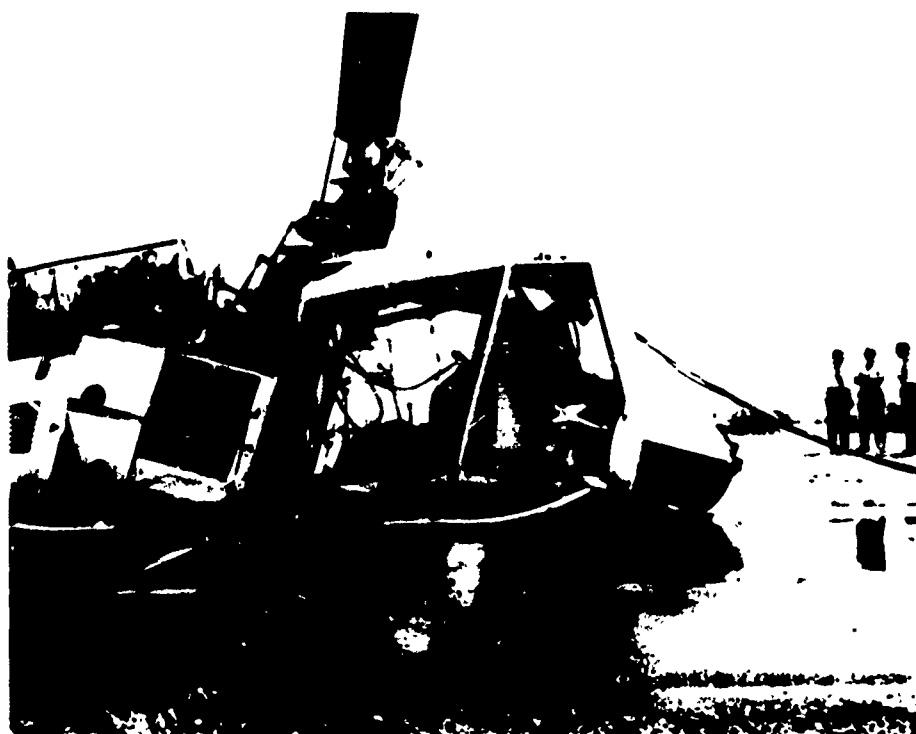
The XH-40 was dropped from a moving crane with impact parameters of 44 feet per second forward and 40 feet per second downward. The litter system did not function as planned owing to failure to the forward litter straps at the stitching. Certain conclusions can be drawn from the test, however, which demonstrate even more the need for the development of a crashworthy aeromedical evacuation system. The litters failed at a G level of approximately 20G. The standard litter system previously failed at approximately 9G. This means that a system of more than twice the strength of the standard litter system still fails with catastrophic results in a potentially survivable crash.

Figure 35. Postcrash XH-40 - Right Side View.

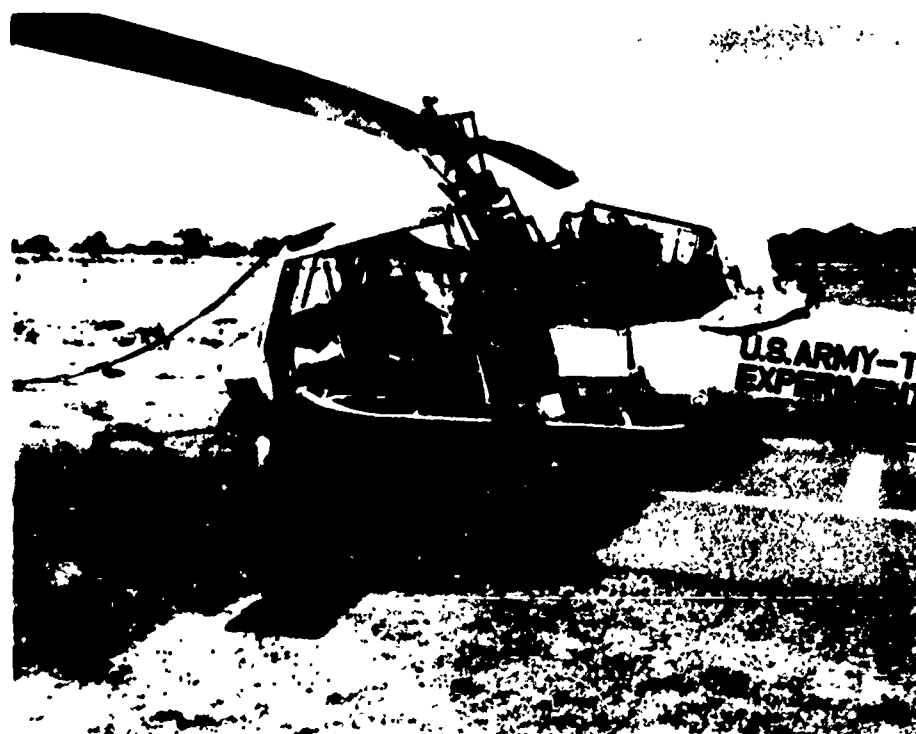
Figure 36. Postcrash XH-40 - Left Side View.

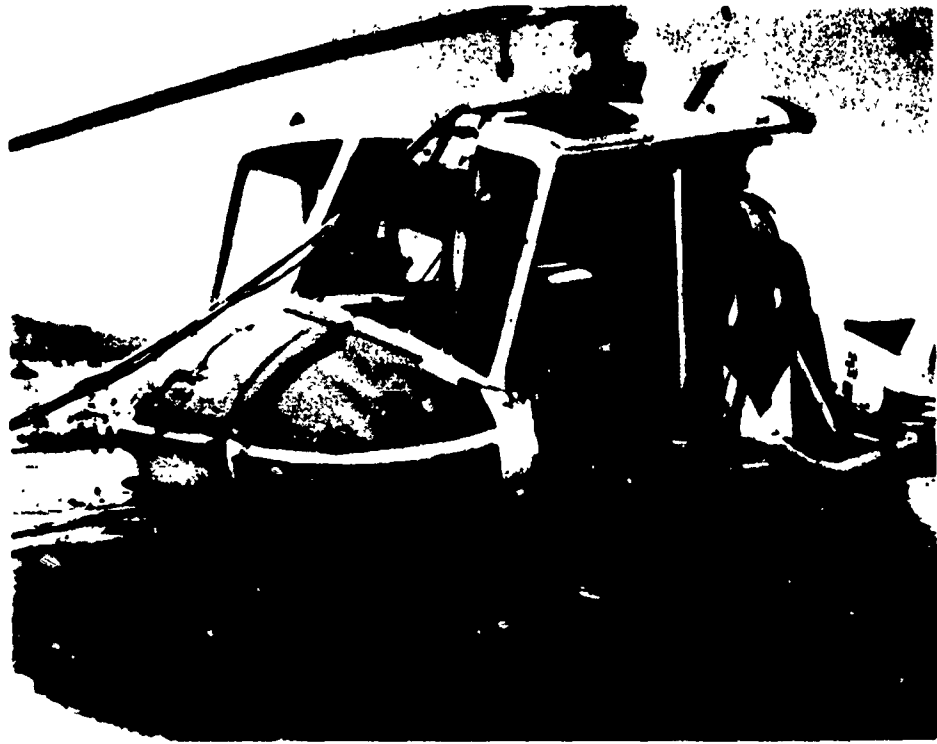
Figure 37. Postcrash XH-40 - Left Front View.
